Subject: **ACTION:** LTPP Directive D-54  
Distress Survey Photographs

**Directive Number:** D-54

**Subject:** Distress Survey Photographs

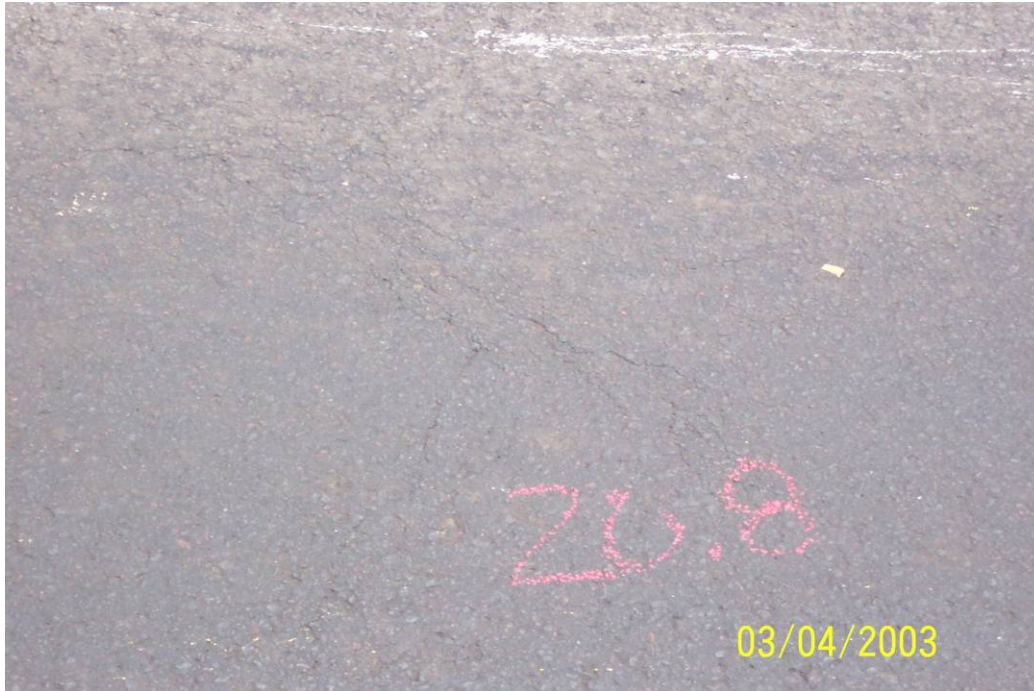
### Image 1

This photo has nothing to indicate scale or direction. When such a photo is taken, these need to be included within the description. An example of a good description is provided below.

Description: "Non-standard photo - AC surface with several unusual low severity cracks running transverse to lane."

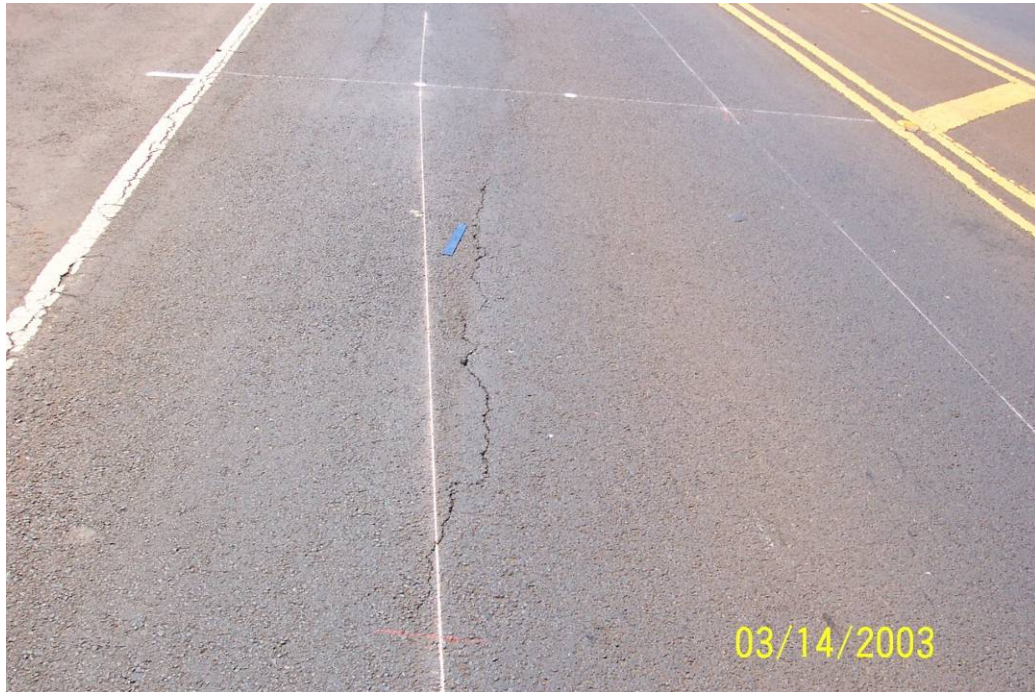
**Image 2**

Description: "Non-standard photo - a crack in the AC surface developing along an unconventional longitudinal paving seam."

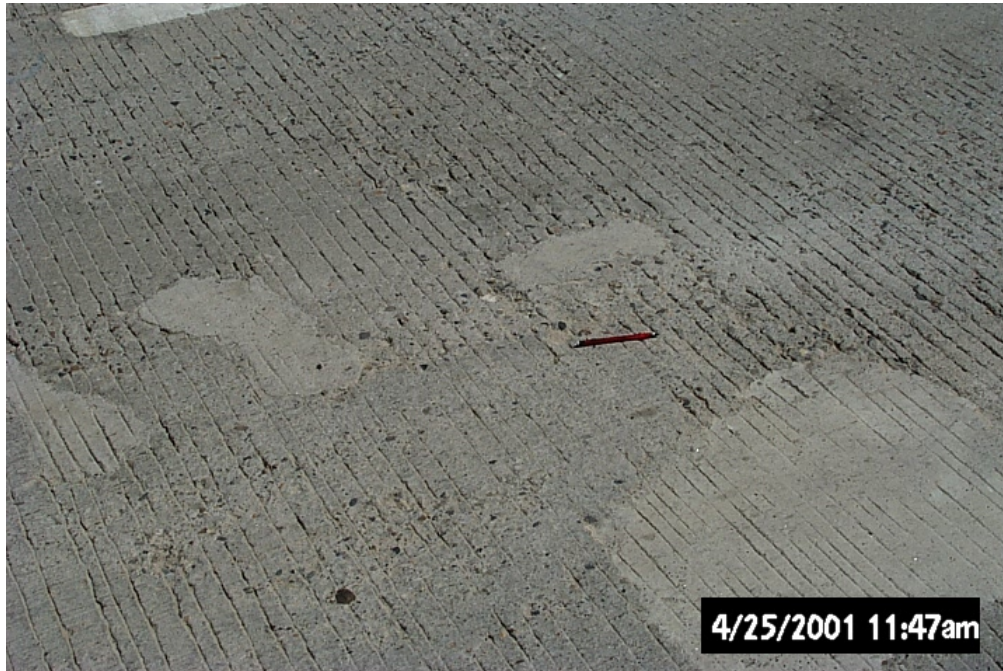
**Image 3**

The Portland cement concrete patches in this image will have been noted on the survey maps and forms. There does not appear to be a good reason why this photo was necessary and thus it may be omitted. Nonetheless, a possible description is provided below.

Description: "Non-standard photo - small closely spaced PCC surface patches."

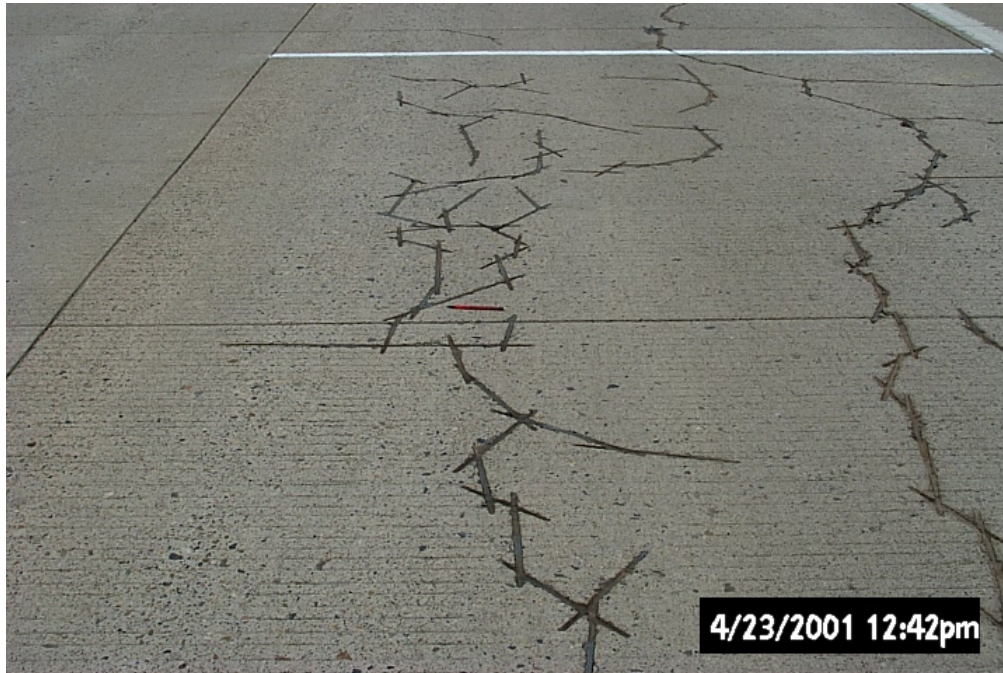
**Image 4**

Description: "Non-standard photo - PCC pavement with a series of short interconnected cracks that have been saw-cut and sealed."

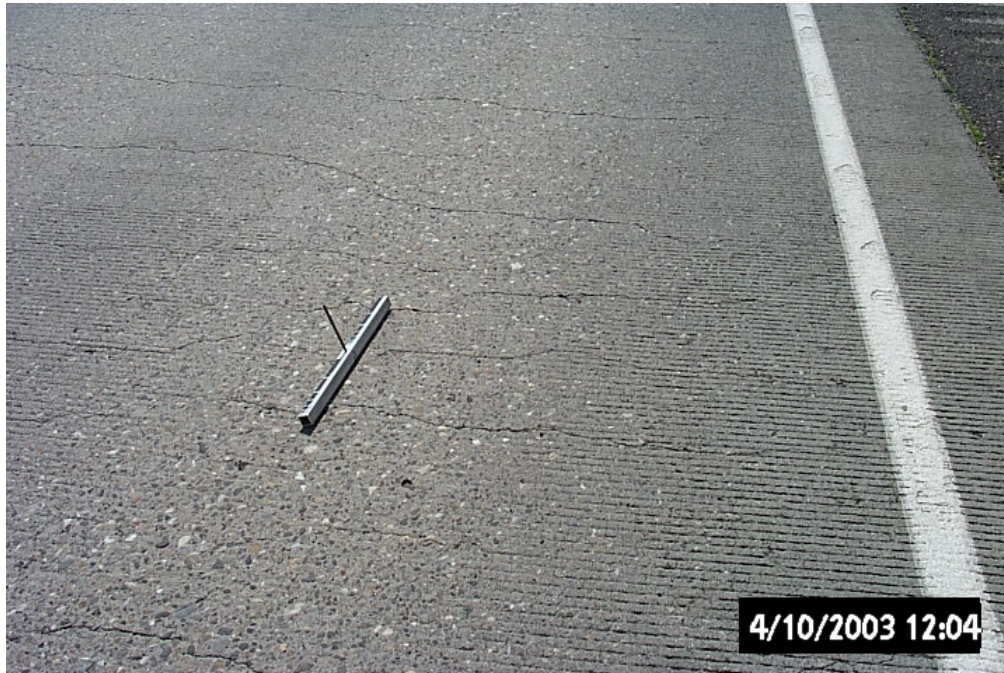
**Image 5**

These transverse cracks will have been noted on the survey forms and maps. A nonstandard photo is not warranted unless the surveyor feels that this photo is noteworthy for another reason. If this was the case, the reason should be included in the description of the photo. A possible description is provided below.

Description: “Non-standard photo - transverse cracks on CRCP pavement lacking apparent interconnection between adjacent cracks or extension to the outer pavement edge.”

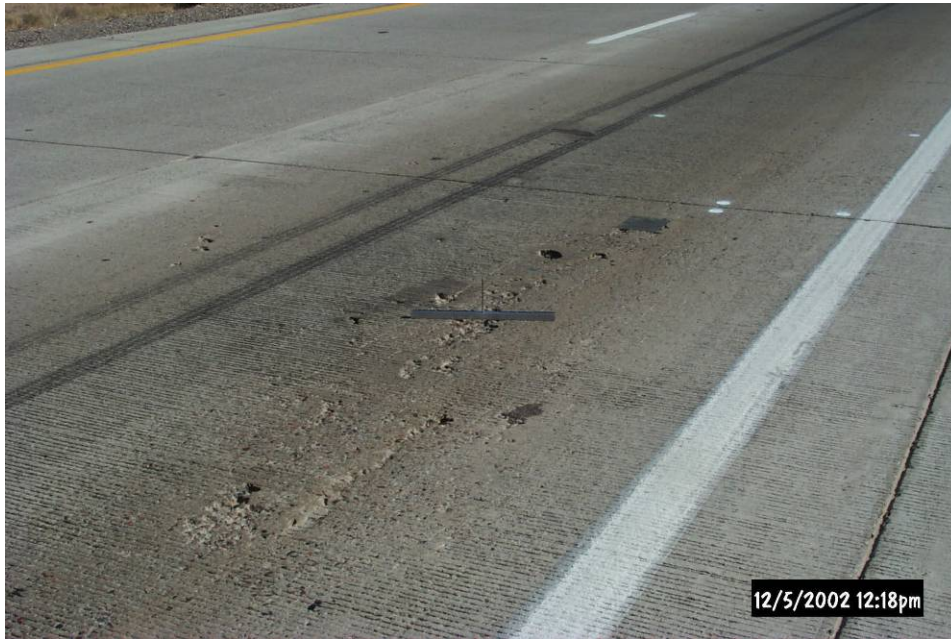
**Image 6**

Description: "Non-standard photo - PCC pavement with surface material missing from the left wheel path."

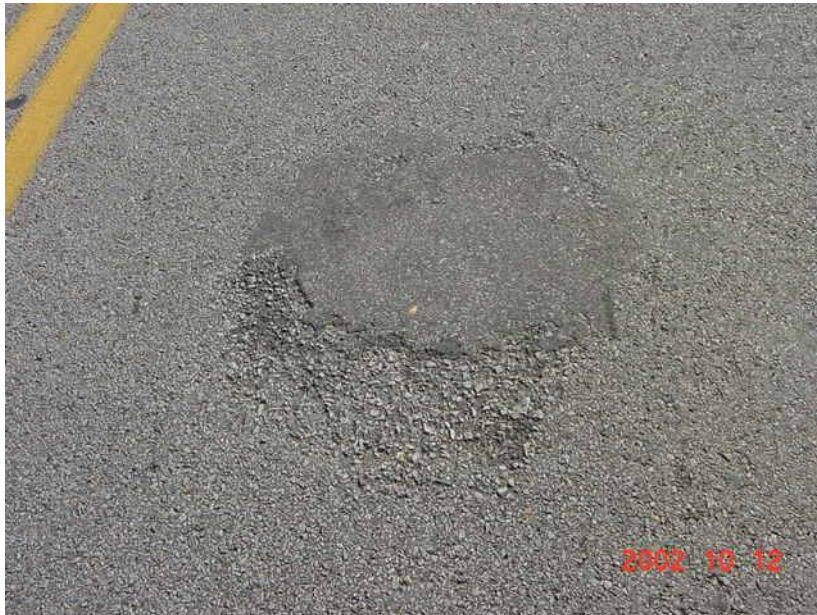
**Image 7**

The distresses in this photo are easily recognizable and should have been recorded on the distress maps and forms. Unless the surveyor feels that the photo is noteworthy or of particular interest to users of the distress survey data, then the photo is not warranted. Nonetheless, a possible description is provided below.

Description: “Non-standard photo - circular AC patch with small area of adjacent raveling.”

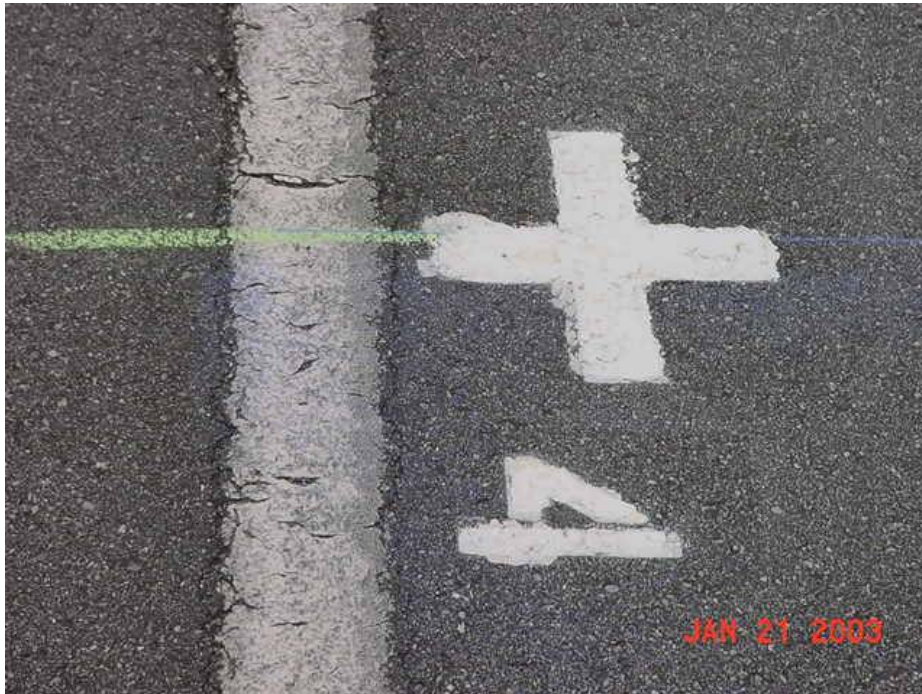
**Image 8**

Description: “Non-standard photo - fine cracks propagate across the painted edge line as well as longitudinally along both sides.”

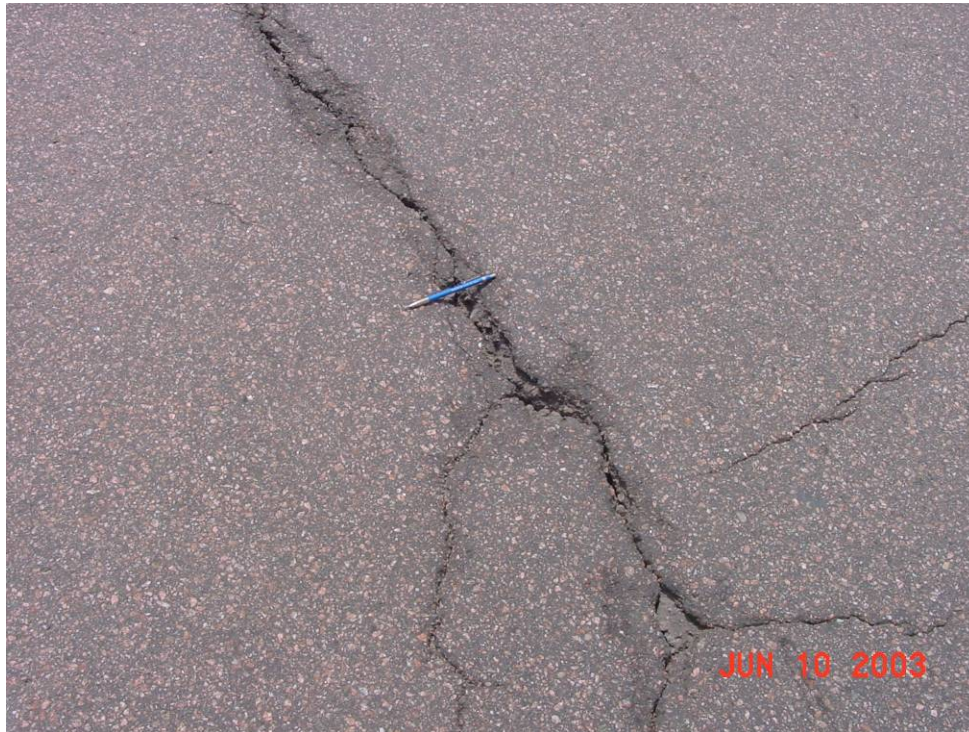
**Image 9**

This photo lacks an indication of direction. It is important that the orientation of the cracks can be determined. The description should clearly state this. A possible description is provided below.

Description: "Non-standard photo - severe transverse crack extending across the lane and a series of smaller cracks radiating from it, perpendicular and diagonal to the lane."

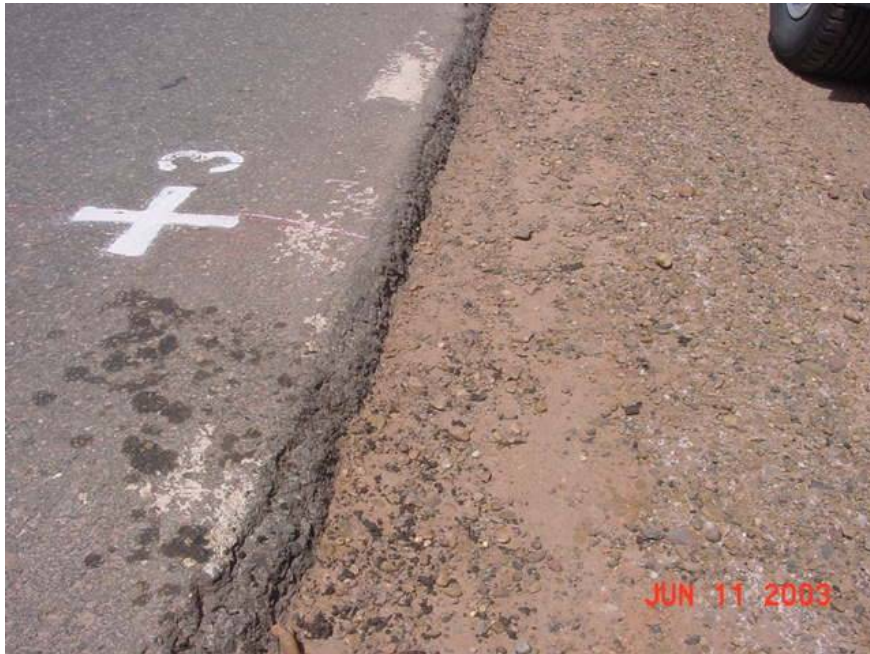
**Image 10**

Description: "Non-standard photo - worn pavement edge line."

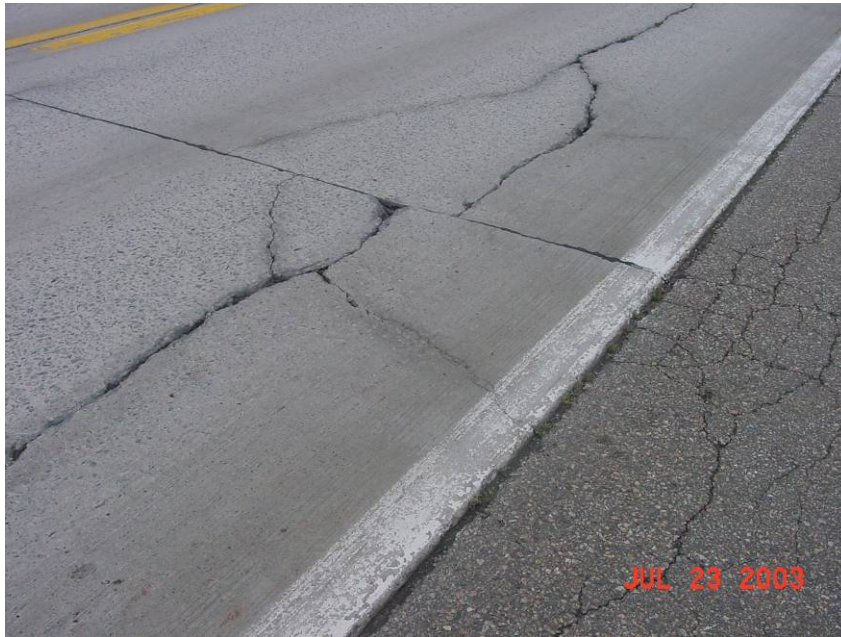
**Image 11**

Note: If the diamond grinding in this image is visible in standard photos, then this non-standard photo is not required.

Description: “Non-standard photo - transverse joint, a severe longitudinal crack with polished aggregate to the left and striations caused by diamond grinding to the right of it.”

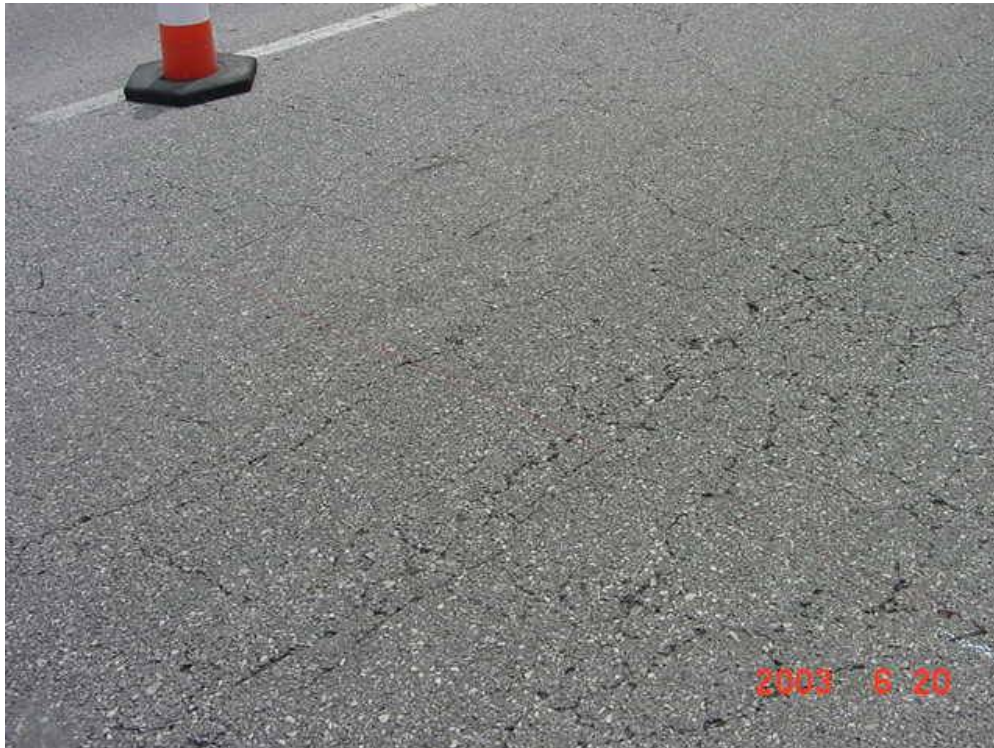
**Image 12**

“Non-standard photo – a chicken wire pattern of cracking across the whole lane.”
